5th September 2013
Our ref 7136

Home Farm
AMMERDOWN ESTATE
Kilmersdon
Bath BA3 5SN
t. 01761 420300
f. 01761 420400
t. (Cliveden) 01628 604721

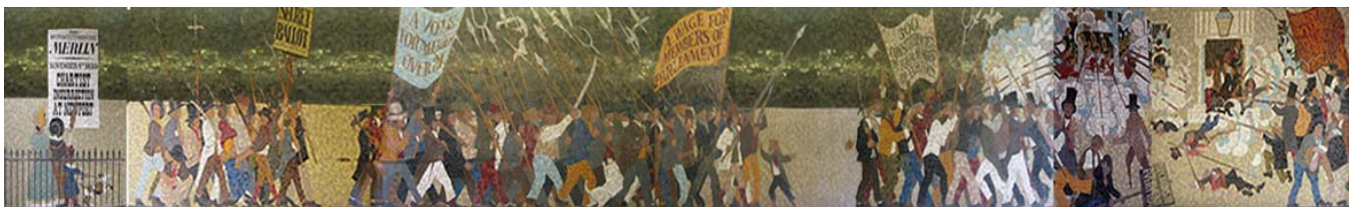
Object: Chartist Mosaic
Dimensions: 124m², W 35.0m x H 4.0m
Location: John Frost Square Underpass, Newport
